DAM INSPECTION CHECKLIST POSSUM POINT POWER STATION POND ABC

INSPECTION DATE: April 13, 2016

INSPECTED BY: K. ACREE

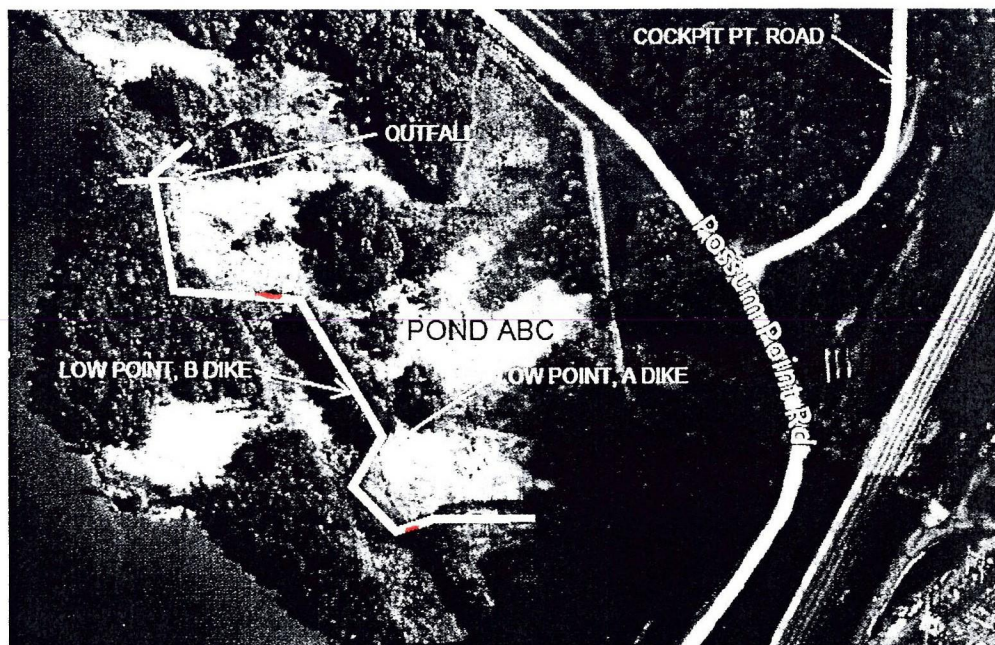
Location/ Condition	(y/n)	Change (y/n)	Comments
Low Point, A dike*			
Flow	N	N	11:05 → SAND BAGS AND RIPRAP ARE IN-PLACE.
Erosion	N	N	NO STANDING WATER OR FLOW AT SAND BAGS. SEVERAL SAND BAGS ARE RIPPED.
Low Point, B dike*			
Flow	N	N	11:07 → SAND BAGS ARE IN-PLACE AND NO STANDING WATER
Erosion	N	N	IS AGAINST SAND BAGS. SOME SAND BAGS ARE RIPPED.
Outfall water surface El. (top of stoplogs to water)			11:13 → NO STANDING WATER AGAINST THE WEIR, WEIR APPEARS TO BE DRY, AND NO FLOW THROUGH WEIR.

Additional Comments (Note any changes observed along the embankment crest or downstream slope observed from the crest.): - LOW POINT, C DIKE → (11:11) → SAND BAGS ARE IN-PLACE + NO STANDING WATER AGAINST SAND BAGS. SEVERAL SAND BAGS ARE RIPPED. NO FLOW OBSERVED.
- POOLED WATER WITHIN POND C (TYPICAL OF PONDS A+B, BUT LESS VOLUME PRESENT THAN IN POND C)

- ~~WATER~~ STANDING WATER AT TOP OF EMBANKMENTS TO PONDS A, B, & C. (SEE FIGURE BELOW)
